Attached is the revised Draft Final RTCs package for the Parcel E-2 Phase II RACR including the originally missing EPA comments from August 6, 2020. This submittal allows EPA a 30-day review period in response to comments received, but not previously addressed. The new comments are in **GREEN** with the updated responses in **RED**.

FIGURE 7
**TIDAL WETLAND FINAL CHEMICAL
CONFIRMATION SAMPLE GRIDS**
REMEDIAL ACTION COMPLETION REPORT
PARCEL E2
HUNTERS POINT NAVAL SHIPYARD, SAN FRANCISCO, CA

Response to Comments on the Draft *[Final] Remedial Action Completion Report, Parcel E-2 Phase II, Hunters Island, San Francisco, California, June 2020, DCN: APTM-2005-0013-0047*

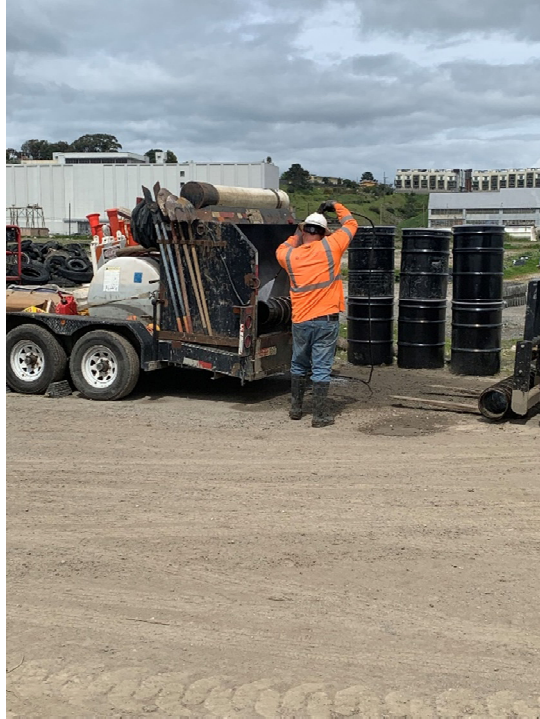
Cascade Drilling Performing Steam Cleaning of Drilling Augers during Installation of Upgradient Well Network Parcel E-2. April, 4 2019

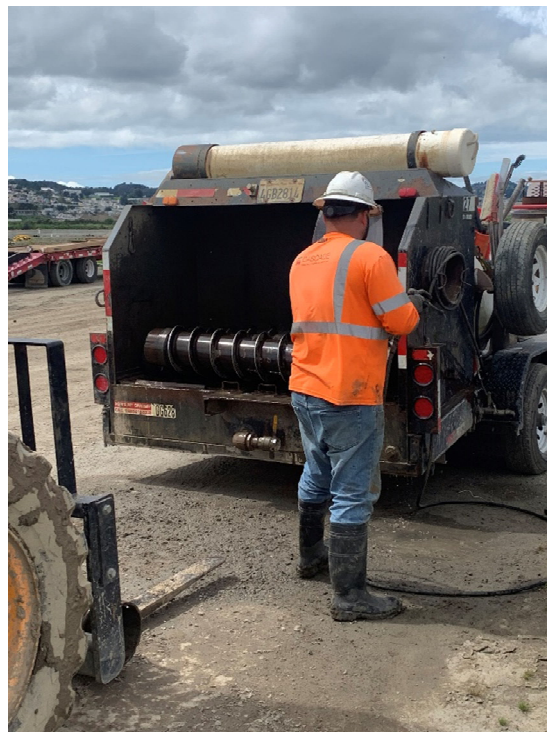
Cascade Drilling Performing Steam Cleaning of Drilling Augers during Installation of Upgradient Well Network Parcel E-2. April, 4 2019

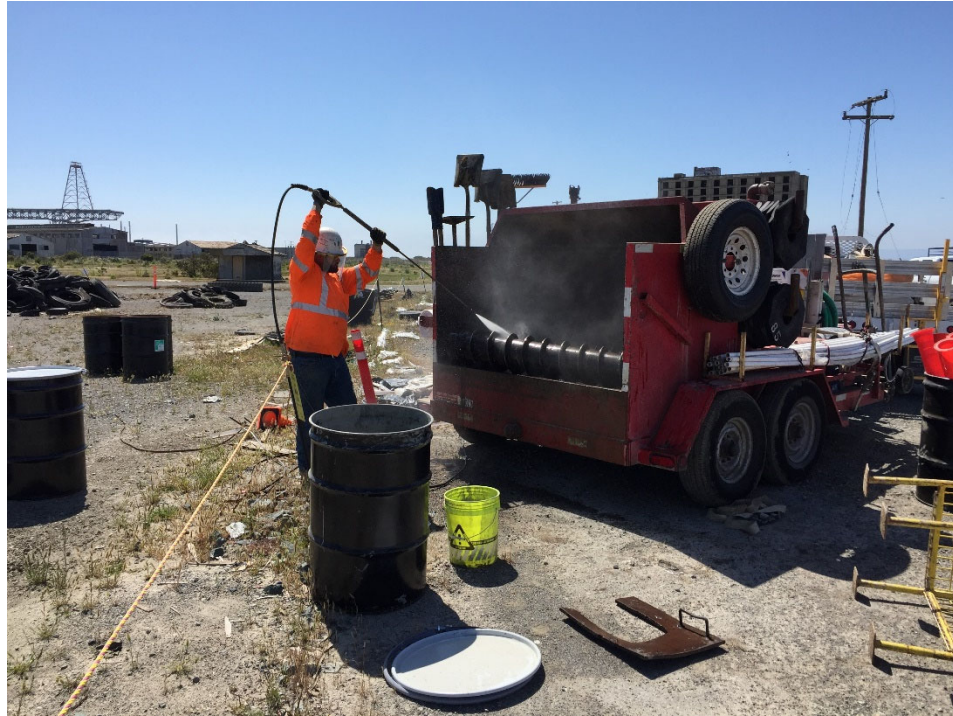
Cascade Drilling Performing Steam Cleaning of Drilling Augers during Installation of Upgradient Well Network Parcel E-2. June 2019
